Removing Unwelcome Tower Basin Dirt Accumulation at Plastics Manufacturer

Application: BAC 1500 Series Cooling Towers

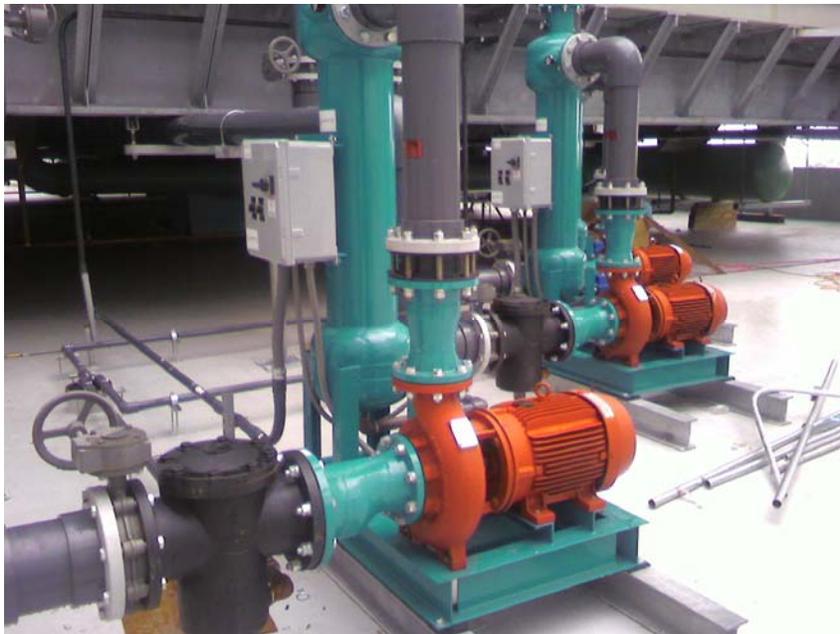
Equipment prescribed: Puroflux PF-64 Series Hydrocyclone Particle Separators with Basin Sweeper Piping and Sweeper Jet Systems.
